Our ref CA281-1/IJC  
File ref R-01  
Date 15 November 2011

## NSW Railways – polishing of graffiti scratches on toughened glass surfaces

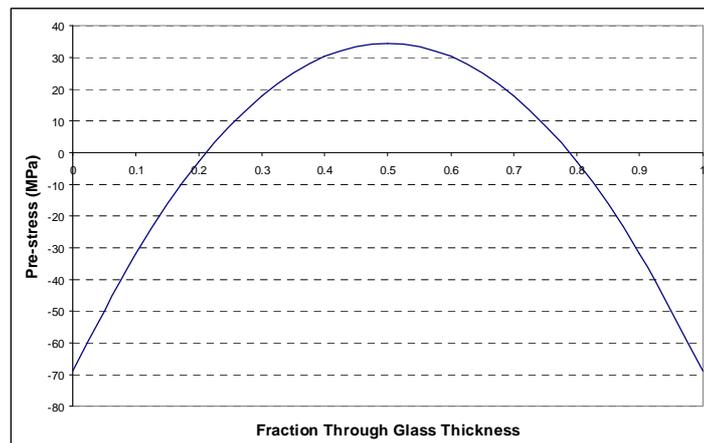
**Figure 1 Typical parabolic stress distribution of toughened glass having a surface compression stress of 69 MPa.**

For the parabolic distribution of stress through the thickness, the depth of the compression layers is of the order of 0.2 times the glass thickness (see Figure 1). Thus, for 6 mm glass thickness the depth of the surface compression layers is 1.27 mm.

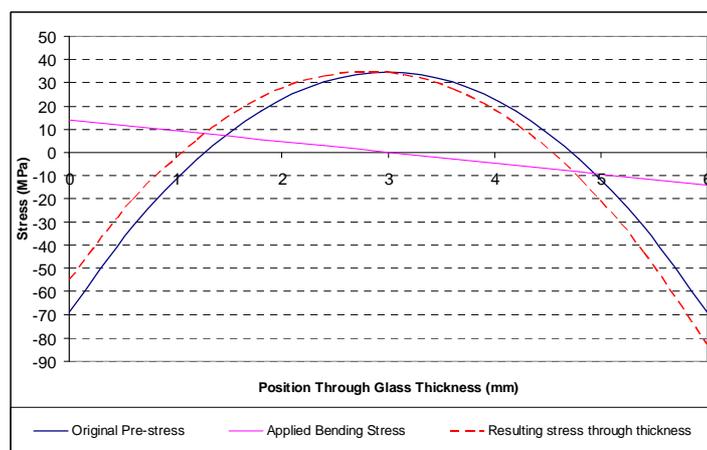
**Figure 2 Stress distribution through 6 mm toughened glass having a 14.09 MPa maximum bending stress superimposed on the distribution for a surface compression pre-stress of 69 MPa.**

From Figure 2 it can be seen that for this example, when the bending stress is superimposed on the toughening pre-stress, then the surface compressive zone is reduced to 1.05 mm deep one surface and increased to 1.46 mm deep on the other surface. Therefore, a scratch of depth up to 1 mm would still be within the surface compression layer.
